ERIKS Technical Center

Title O-Ring & Backup Failure Analysis

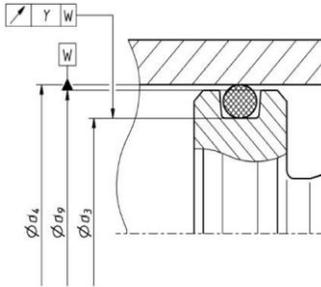
The O-ring and backup were received into the Tech Center on 7/29/10 for analysis. According to the information received, the O-ring and back up were being used in a static piston seal in nitrogen at temperatures up to 350 °F (177 °C) and pressures up to 10,000psi. The leak occurred when the pressure reached 7,500 psi.

The gland depth is 0.188", width of 0.4125" – corresponding to a compression of (10.5% = $1 - 0.188/0.21$) typical, and stretch ($5.631/5.6 = 101\% > 1.0$).

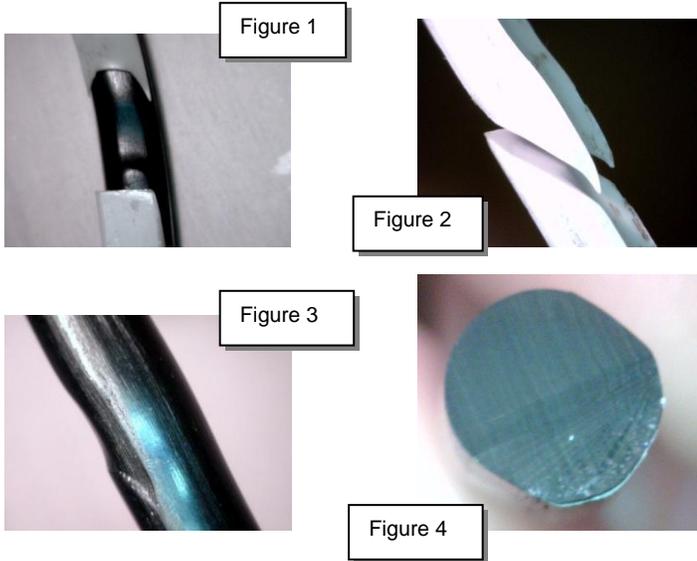
The O-ring experienced a compression set resulting in a radial height of 0.195" and axial width of 0.219" ($68\% = (1 - 0.195/0.21)/.105$). The hardness was measured at 95-100 Shore A and the specific gravity at 1.12.

The backup experienced deformation at the scarf cut suggesting that it might be too large for the gland dimensions. Due to the backup being too large, the scarf cut would overlap itself. When pressurized, the O-ring would push the backup towards the gland wall, pulling the material

On the O-ring, there is an indentation from the backup scarf cut causing an axial gap as well as a radial gap. The axial gap is most likely where the leakage occurred. The material deformation and the compression set suggest that the operating temperature is too high for the HNBR being used.

The backup deformation resulted from an overlapping of the scarf cut. This overlapping was most likely caused by the back up being too large for gland. The damage to the O-ring would suggest that it was exposed to high temperatures leading to high compression set. The leak would have occurred at the location of the axial gap caused by the backup scarf cut. An elastomer with better thermal property retention would be recommended in addition to updating the backup dimensions to better fit the in gland dimensions.
