### 20. Troubleshooting

#### O-ring Failure

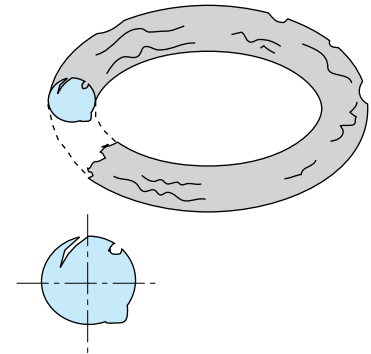
**Failure Pattern:** Typical of high pressure systems, this pattern can be identified by the many small bites (nibbles) taken from the O-ring on the downstream (low pressure) side.

**Problem Source:** excessive clearances; excessive system pressures; O-ring material too soft; degradation of the O-ring by system fluid; irregular clearance gaps caused by eccentricity; improper machining; sharp edges; or the O-ring size is too large for the gland.

Picture of an extruded, nibbled O-ring

**Suggested solution:** decrease gland clearances by machining; use back-up rings to prevent extrusion; employ harder O-rings; re-check elastomer compatibility; improve concentricity; break sharp edges; or install proper size O-ring.

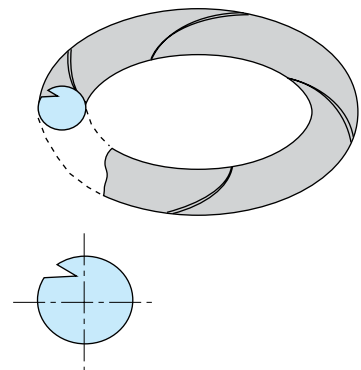
**Failure pattern:** generally found on long stroke hydraulic piston seals with low pressure differential. The surface of the O-ring exhibits a series of deep, spiral, 45° angle cuts.

**Problem source:** caused when certain segments of the O-ring slide while other segments simultaneously roll. At a single point on its periphery, the O-ring gets caught on an eccentric component, or against the cylinder wall, causing twisting and development of 45° angle, surface cuts.

Picture of a spiral failure O-ring

**Suggested solution:** check for out of round cylinder bore; decrease clearance gap; machine metal surfaces to 10-20 micro-inch finish; improve lubrication; use internally-lubricated O-rings; employ back-up rings; employ Quad-Rings®/X-Rings; or in severe cases use a T-seal.

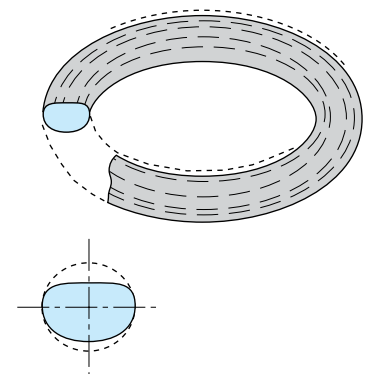
**Failure pattern:** Occuring primarily in dynamic seals involving reciprocating, oscillating, or rotary motion. This failure pattern can be identified by a flattened surface on one side of the O-ring's cross section or wearlines on the cross section parallel to motion.

**Problem Source:** Metal surfaces too rough (acting as an abrasive); metal surfaces too smooth, causing inadequate lubrication; poor lubrication; excessive temperatures; or the system is contaminated with abrasives.

Picture of an abrasion affected O-ring

**Suggested solution:** use recommended metal finishes; provide adequate lubrication; check material compatibility with system temperature; or eliminate abrasive contamination with filters.

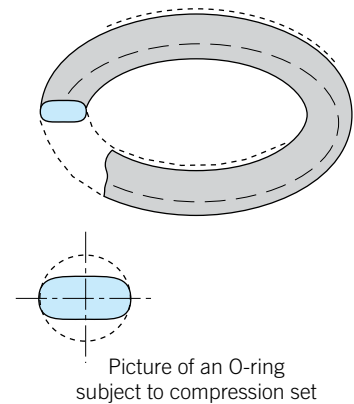
#### Compression Set

**Failure Pattern:** common to both static and dynamic seals, compression set failure produces flat surfaces on both sides of the O-ring cross section in the area being squeezed.

**Problem Source:** selection of an elastomer with poor compression set properties; system pressure is too high; excessive swelling of O-ring material in system fluid; too much squeeze to achieve seal; incomplete curing of O-ring material during vulcanisation; or excessive system temperature.

**Suggested Solutions:** employ a low compression set elastomer; specify an O-ring material that resists operating or frictionally generated heat; re-check O-ring compatibility with system chemicals; reduce O-ring squeeze if possible; or inspect incoming O-rings for correct physical dimensions.

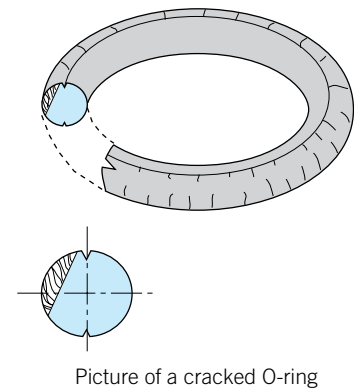
#### Weather or Ozone Cracking

**Failure Pattern:** occurring in both static and dynamic seals exposed to atmospheres containing ozone and other air pollutants. This failure mode is marked by the appearance of many small surface cracks perpendicular to the direction of stress.

**Problem Source:** ozone attacks unsaturated or double bond points in some polymer chains, causing chain scission. Cracking of the outside surface of the O-ring is the result.

**Suggested Solution:** employ O-ring elastomers that are resistant to ozone attack.

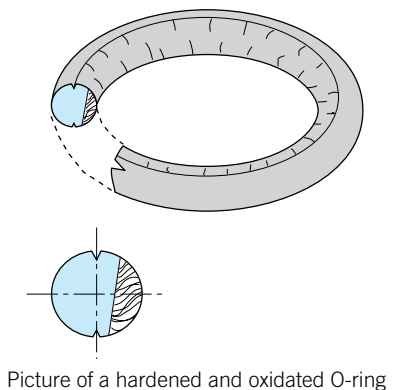
#### Heat Hardening and Oxidation

**Failure Pattern:** seen in both static and dynamic seals, in pneumatic or air service. The surface of the O-ring appears pitted and/or cracked, often accompanied by the flatness of high compression set.

**Problem Source:** excessive environmental temperature causing excessive elastomer hardening, evaporation of plasticizer, and cracking from oxidation.

**Suggested Solution:** lower operating temperature or specify high temperature and oxidation resistant O-ring materials.

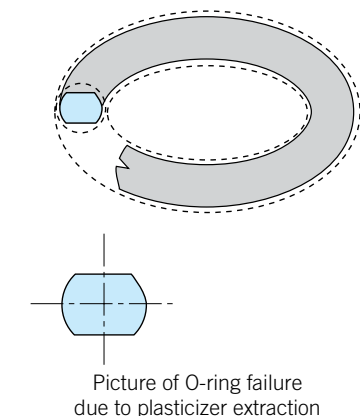
#### Plasticizer Extraction

**Failure Pattern:** occurring in both static and dynamic seals, primarily in fuel system service. This failure pattern is marked by small cracks in the O-ring stress area, accompanied by a loss of physical volume.

**Problem Source:** extraction of O-ring material plasticizer component by system chemicals or fluids in a dry-out situation.

**Suggested Solution:** employ chemically compatible O-ring material with low-to-no extractable plasticizer content.

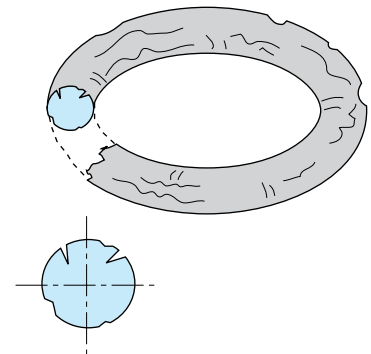
**Failure Pattern:** marked by random short splits or ruptures going deep into the O-ring cross section. When the O-ring is first removed, the surface may also be covered with small blisters.

**Problem Source:** absorption of gas by the O-ring while operating in high pressure conditions. Subsequent rapid decrease in system pressure traps within the O-ring micropores, causing surface blisters and ruptures as the gas seeks an avenue of escape.

Picture of an exploded O-ring

**Suggested Solution:** increase time for decompression; increase material hardness to 80°-95° shore A; reduce O-ring cross sectional size; or specify a decompression resistant material, such as a harder nitrile or special Viton® 514162.

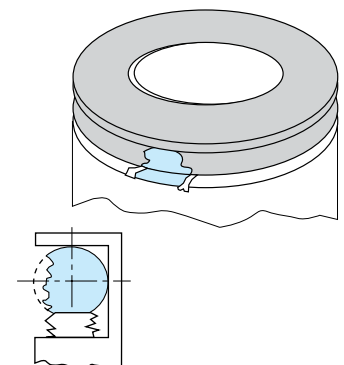
**Failure Pattern:** occurring exclusively in dynamic seals, the O-ring surface is notched or nibbled adjacent to the scarf cut or overlap of the back-up ring.

**Problem source:** thermal changes, pressure surges, and extrusion of the back-up ring into the gap.

Picture of a damaged back-up and O-ring

**Suggested Solution:** check design details and consider the solid type of back-up ring. Use PEEK (plastic) or another material.
